This is an Emergency Safety Order to correct and remove an imminent danger.

Safety Alert

Subject: E-Series 5000 Escalator -
Welds on Lower Track Sub-Assembly

E-Series 5000 Escalator - Welds on Lower Track Sub-Assembly

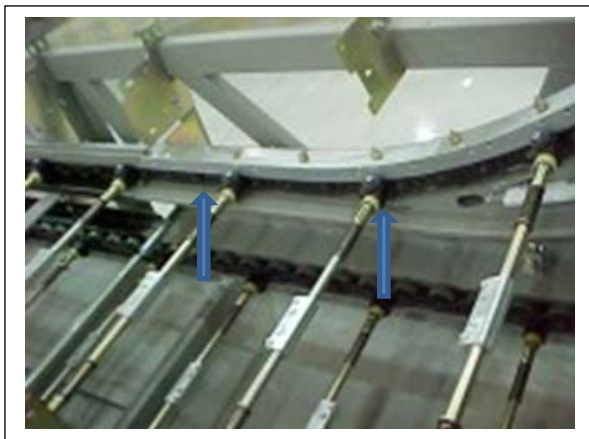
Figure 1. Identification of weld areas

There have been instances of broken welds on the lower track sub-assemblies in the areas shown between the arrows of Figure 1 & 2.

The welds in the areas shown will be either on the top or on the bottom surface of the track and should meet the following criteria as a **minimum**:

- Welds should be 1/8 inch in width. Wider is acceptable as long as the step chain wheels do not roll against the weld.
- Welds should be 1/2 inch to 3/4 inch in length. Welds must **NOT** be shorter than 1/2 inch in length.
- Spacing from the center of one weld to the center of the next weld is to be no more than 8 inches. Closer spacing is good (although a continuous weld bead could cause distortion of the track sub-assembly).

If the existing welds do not meet the criteria specified above, a repair will be required to strengthen the welds.

If inspection reveals that the track is bent down in this area, an immediate repair is required.
Refer to the Repair Instructions below.

The prescribed method to strengthening/repair the track sub-assembly is to move the displaced track back into position and secure it in this position by adding a series of welds that are 3/16 in. [4.76mm] wide and 3/4 in. [19.05mm] long, with a center-to-center spacing of not greater than 4.00in. [101.6mm]. The repair welds can be added to the top surface of the track.
